**NBSIR 74-474**

# **Metallurgical Analysis of Wear Particles and Wearing Surfaces**

Metallurgy Division  
Institute for Materials Research  
National Bureau of Standards  
Washington, D. C. 20234

Final Report  
NAONR-31-73  
NR 229-014

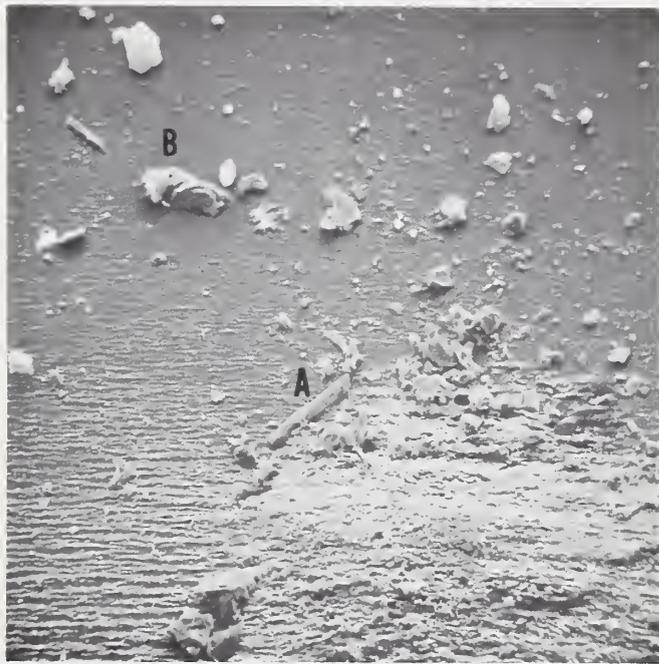
Fig. 1(a). Ferrogram F-2273, oil sample from helicopter gear transmission box. Oil flow is downward. Initial particle deposit region is shown.  $M = 100\times$ .

The transmission from which this sample was taken had failed after a few hours of operation. There were many foreign or unusual particles detected on this Ferrogram that was produced at Trans-Sonics. The discussion will consider the classes of particles observed, originating at either gear or bearing surfaces. The entry deposit is shown in Fig. 1. The Ferrogram 2273 has been overcoated with a layer of vacuum-evaporated carbon. Some charging is seen at particles within the heavy, initial deposit. Many particles larger than  $10\mu\text{m}$  are found near the entrance end of F-2273. Several small spheroidal particles were found (Fig. 1b). One of these is shown in Fig. 2a and contained only iron according to the X-ray emission analysis. A large faceted wear particle of unusual morphology is shown in Fig. 2b. Further down the Ferrogram the usual transverse strings of small wear particles are found, as shown in Fig. 3a. The character of these small ( $< 1\mu\text{m}$ ) rubbing wear particles is seen more clearly in Fig. 3b. A large foreign flake-like particle that is not ferromagnetic has settled there and subsequently the small wear particles were collected in strings that overlay it. The iron peak within the X-ray spectrum from the large flake is actually associated with these small wear particles that have originated from the gear surfaces.

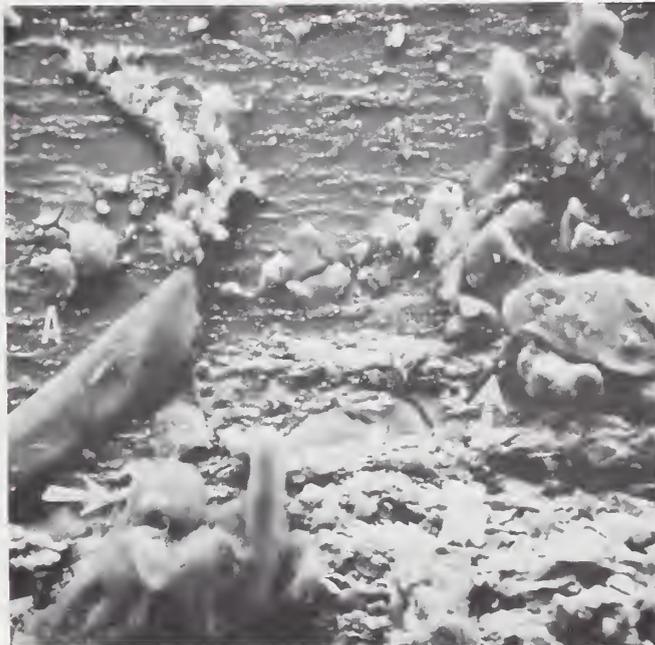
(b). Region near A above. Several spheroidal particles are seen (arrows).  $M = 500\times$ .

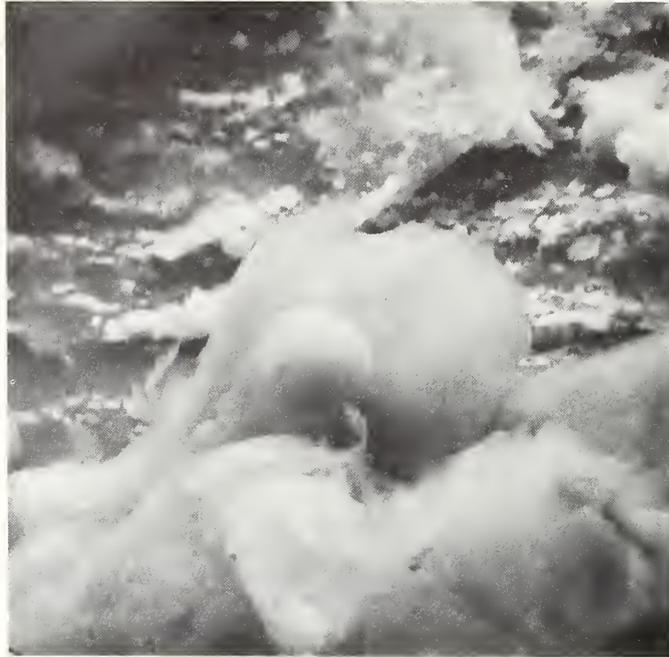
Fig. 2(a). Spheroidal particle shown above. X-ray spectrum indicated only iron in spheroid.  $M = 2,000x$ .

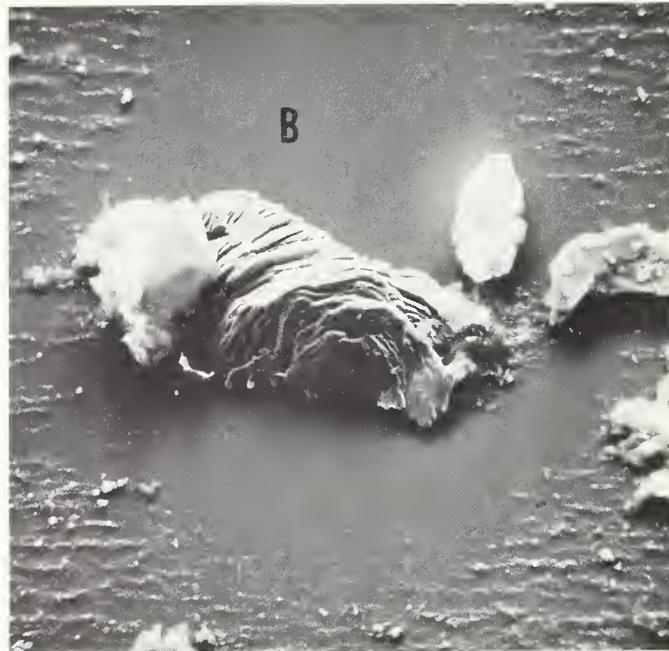
(b). Region B near initial deposit showing large faceted, iron wear particle.  $M = 500x$ .

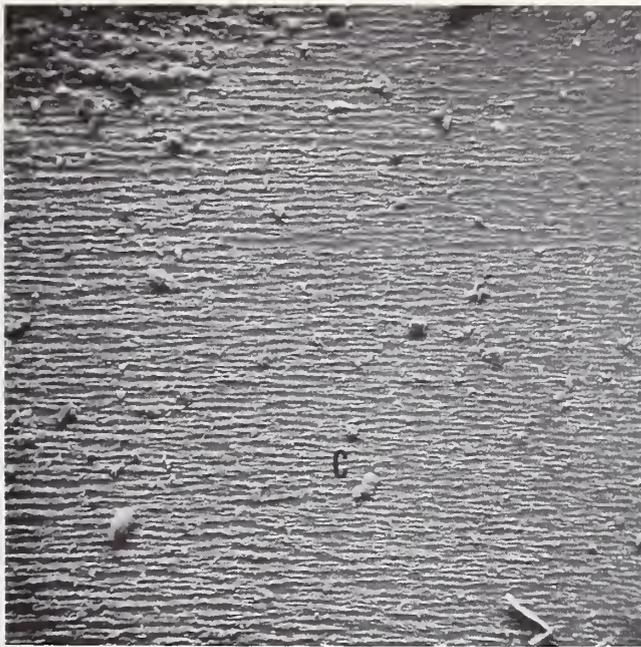
Fig. 3(a). F-2273 region just below initial deposit. Oil flow is downward. Note characteristic transverse strings of small wear particles.  $M = 100x$ .

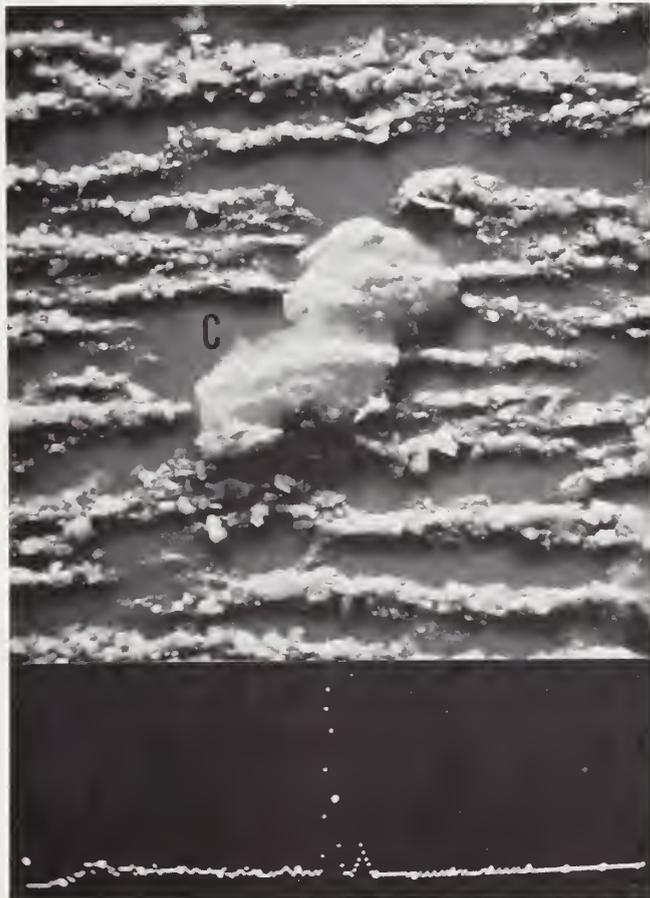
(b). Region C showing large flake underneath small wear particle strings. X-ray spectrum from upper portion of flake is shown.  $M = 1,000x$ .

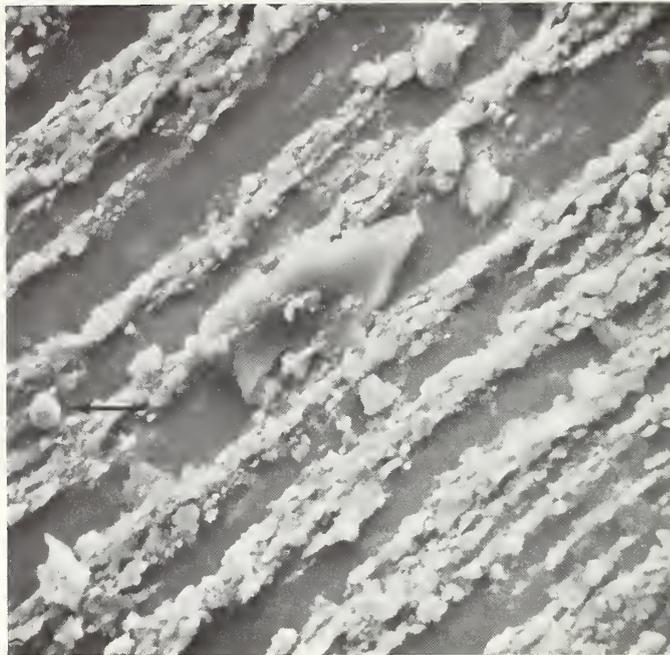
Fig. 4. Region further down from initial deposit in F-2273. Note spheroid at arrow. Particle size in strings varies from  $5\mu\text{m}$  to well below  $1\mu\text{m}$ . Many flake-like particles are found.  $M = 1,000\times$ .

The wear particle strings further down the Ferrogram are shown in Fig. 4 (rotated from the previous orientation). The variation in particle size within the strings is large. Many flake-like wear particles can be identified. In this field one iron spheroid is seen, as is another large foreign flake-like particle. Recently Cummins *et al.*<sup>8</sup> described observations on wear debris from a spur gear system. They reported principally small particles of thickness  $0.2\mu\text{m}$  or less (note the small particle strings here in Figs. 3 and 4) together with some few spherical particles. The needle-like particles they observed were not found in the present sample. A large, faceted wear particle such as shown in Fig. 2b may originate in a fatigue-cracking process in the manner described by Venkatesh and Krishnamurty in their study<sup>9</sup> of cracking in gear systems.

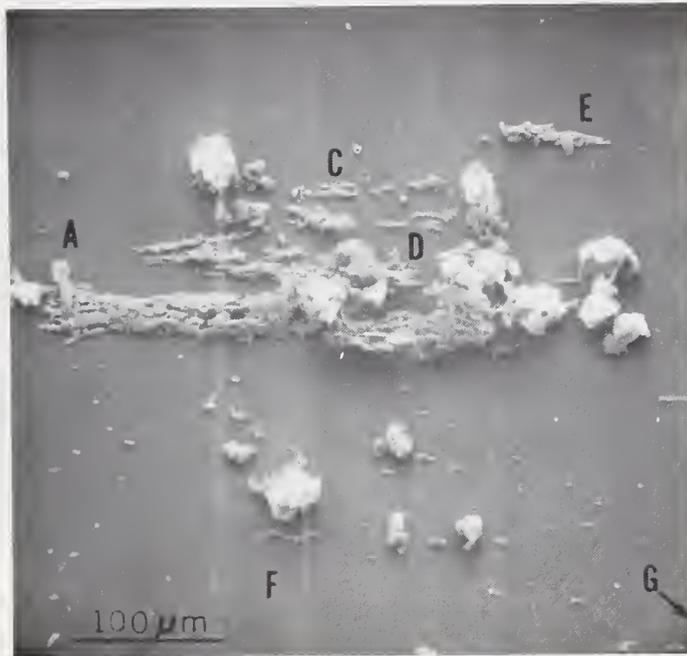
Fig. 5. Ferrogram #2117 from SKF service tank oil, lubricating bearing tests. Carbon-undercoated Ferrogram, scanning electron micrograph, M = 200X. Region shown is at entrance end, oil flow downward. Some particles (metal?) are charging in electron beam due to insufficient electrical contact with substrate. Regions labeled are shown in several subsequent photographs for greater detail on particles.

The oil sample was obtained from SKF and originated from a lubricating system used during rolling bearing tests. The Ferrogram (F-2117) was prepared at Trans-Sonics using carbon precoated slides furnished by us. The same oil had been used previously to prepare F-1851 that was examined and will be discussed later. Optical examination of F-2117 at Trans-Sonics indicated the presence of cutting wear particles, spherical particles, and spalls. The entrance end of

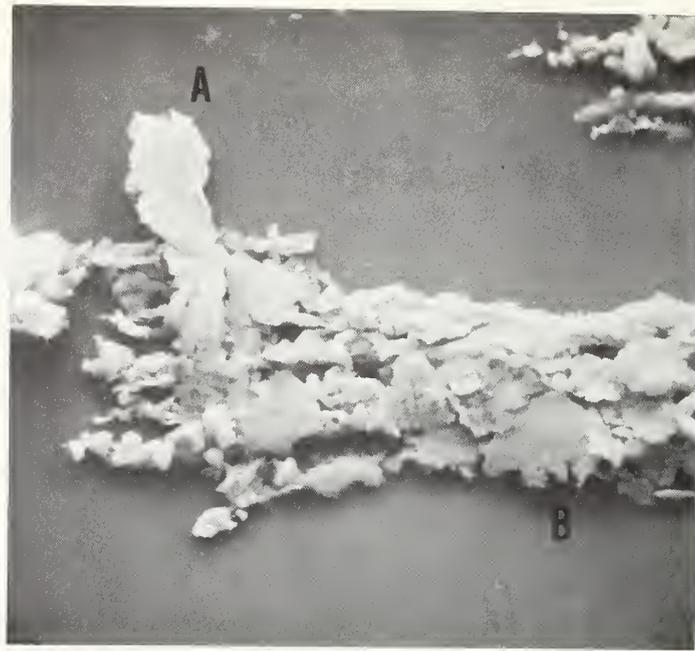
Fig. 6(a). Region A from above. Many flake-like particles are seen in size range 1 to 10  $\mu\text{m}$ .  $M = 1,000X$ .

The region A is shown at higher magnification in Fig. 6. Many flake-like particles are seen, the larger ones being about  $10\mu\text{m}$  in lateral dimensions and of the order of  $0.1\mu\text{m}$  thick. Most of the flakes are bent and corrugated with ragged edges and evident surface features such as lines or bands. Many small particles, less than  $1\mu\text{m}$  in size are also seen. The larger flakes presumably fractured or spalled away from the bearing material during contact wear and stressing. They could subsequently have been further deformed if recirculated through the bearing contact regions by the lubricating oil and even fractured again to produce some of the smaller particles. The expected EHD film thickness would be one-tenth or less the size of these particles (order of  $10\mu\text{-inch} = 0.3\mu\text{m}$ ).

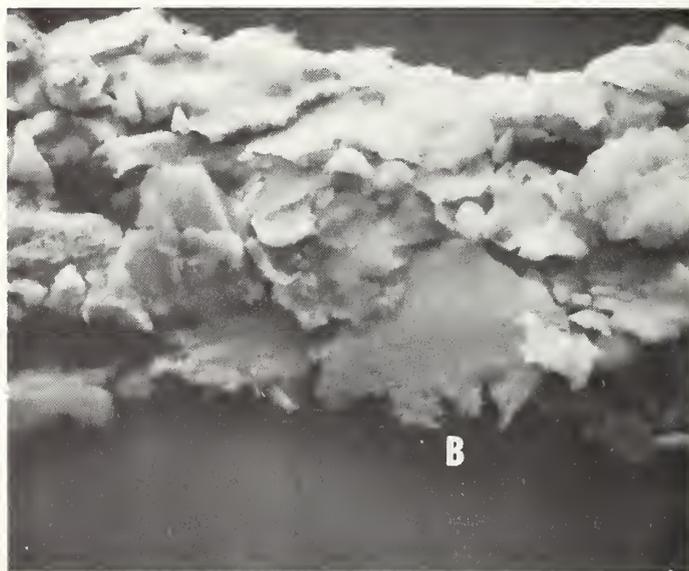
(b). Region near B from above. Surface structures on particles near B appear as slip or deformation lines. Flake above B and flake at left contain only iron.  $M = 2,000X$ .

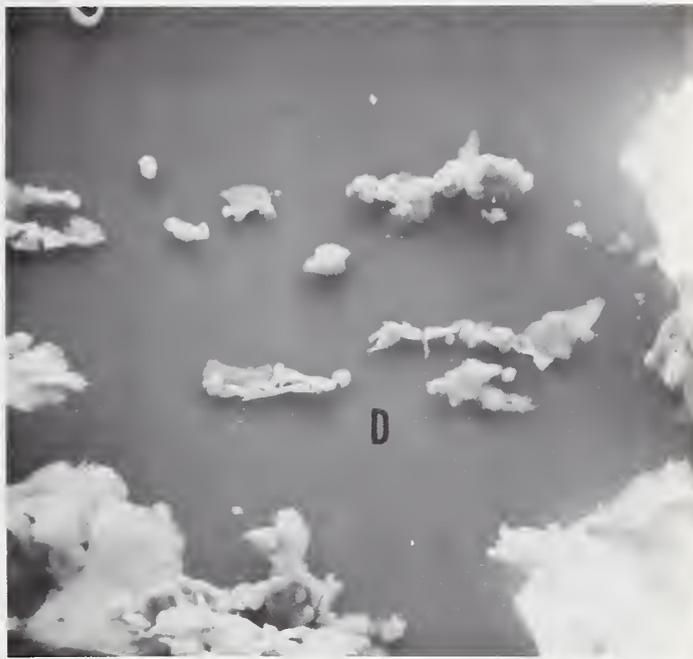
Fig. 7(a). Region D from above. Several small particles strings are shown together with some isolated particles.  $M = 1,000X$ .

Another region from Fig. 5 is shown in Fig. 7. One observes substantial differences in contrast between the particles. The particles showing lower secondary electron emission (grey images) are probably more heavily oxidized and hence contain less iron. Some particles show a porous surface structure that is also suggestive of oxide material. It is recalled that the particles have not been overcoated prior to examination, hence the existing surface structures are preserved. Flake-like particles are observed together with several rod-like particles.

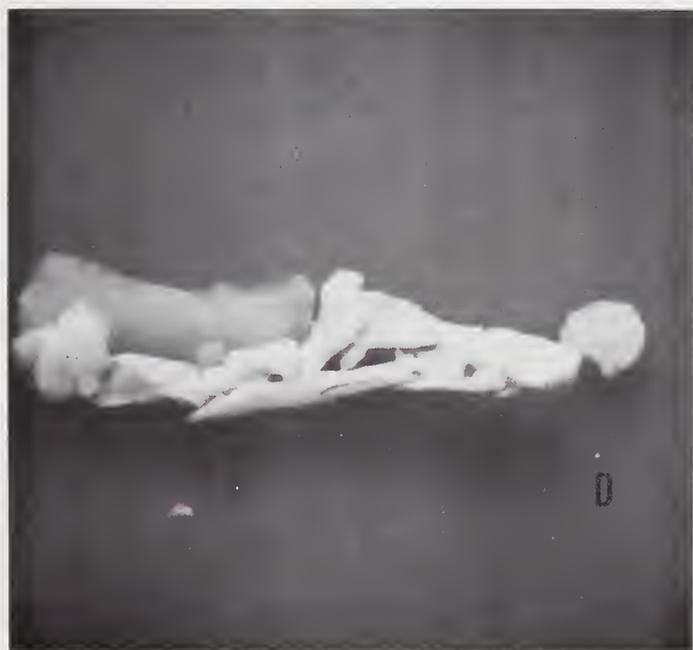
(b). One string from above area containing particles showing different emissive image contrast as previously reported.  $M = 4,000X$ .

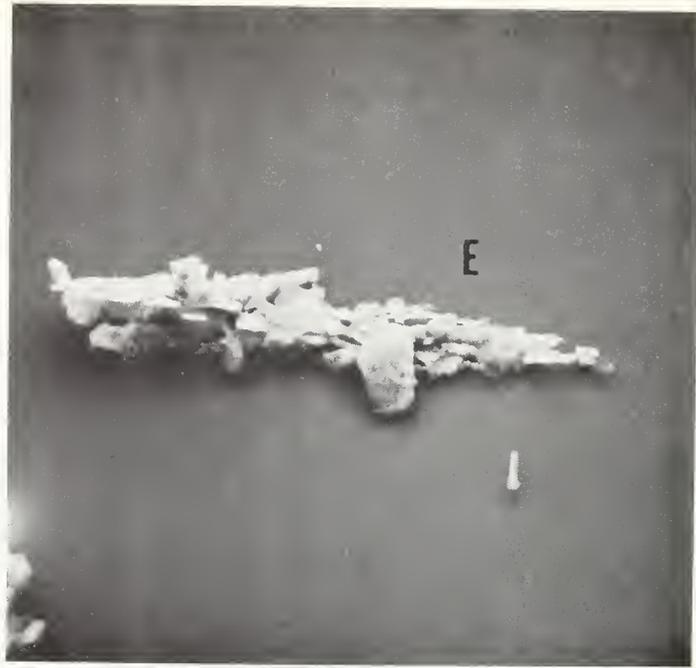
Fig. 8(a). Particle string from Region E in above. Many flake-like particles are seen with resolvable surface structures.  $M = 1,000X$ .

The region E from Fig. 5 is shown in greater detail in Fig. 8. One flake-like particle in this string has considerable surface structure that includes several cracks and smaller, attached particles. A spheroidal particle ( $2.4\mu\text{m}$  diameter) is also seen. Its size is sufficiently large to contain nearly all the X-ray emitting volume permitting meaningful X-ray emission analysis. However, fluorescence effects associated with neighboring particles in such a collection could be substantial and require correction. Analysis of this spheroid showed only an iron peak in the X-ray emission spectra as shown. The large flake-like particle contains a significant amount of iron and zinc.

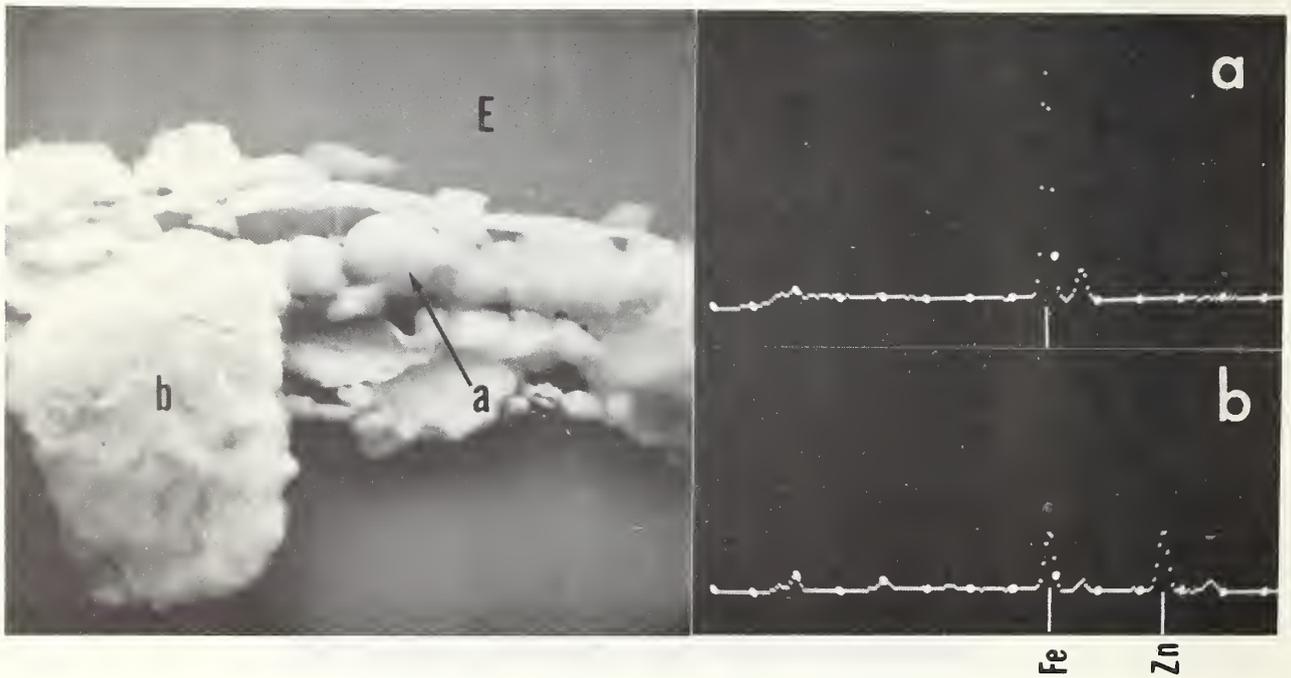
(b). Details in above particle string. Note surface features on large flake at left. Spheroidal particle (a) of  $2.4 \mu\text{m}$  diameter is shown. X-ray analysis indicates (a) spheroid contains only iron and (b) flake has reduced iron and significant zinc content.  $M = 5,000X$ .

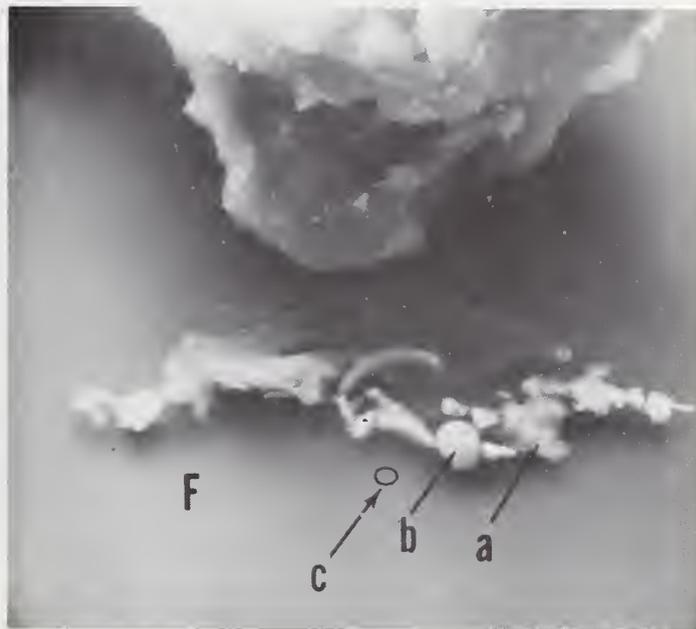
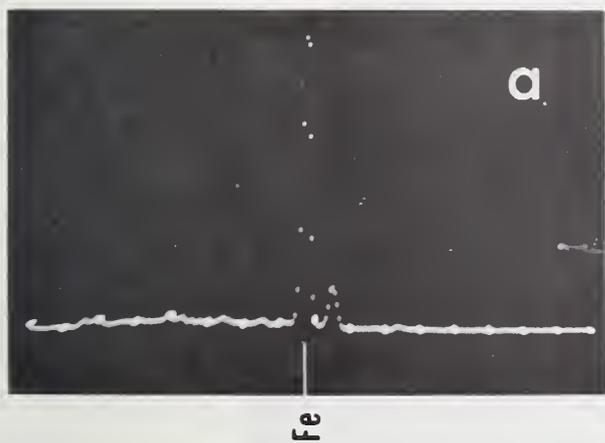
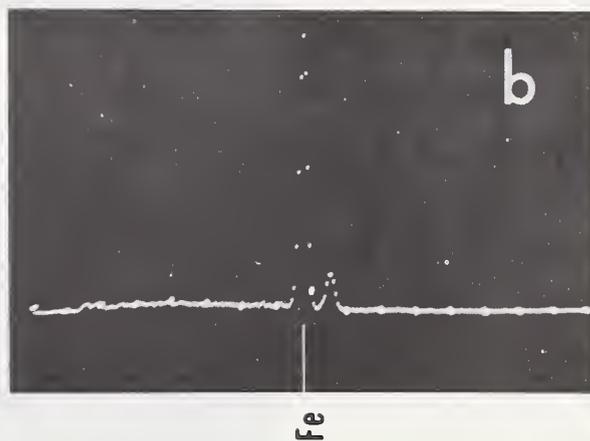
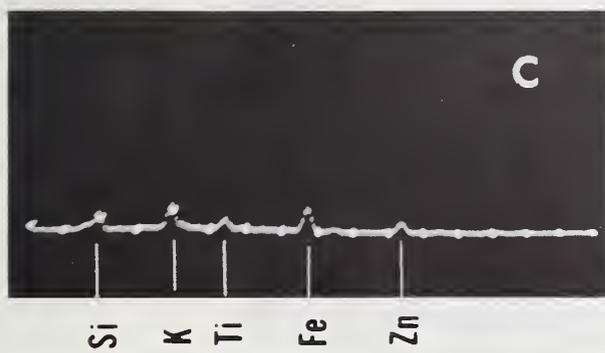
Fig. 9. Region F from above. String contains several particles, one of spheroidal shape (b) of  $2.5 \mu\text{m}$  diameter. X-ray emission spectra are shown for particles (a) and (b) and background region (c). Both particles are iron.  $M = 2,000X$ .

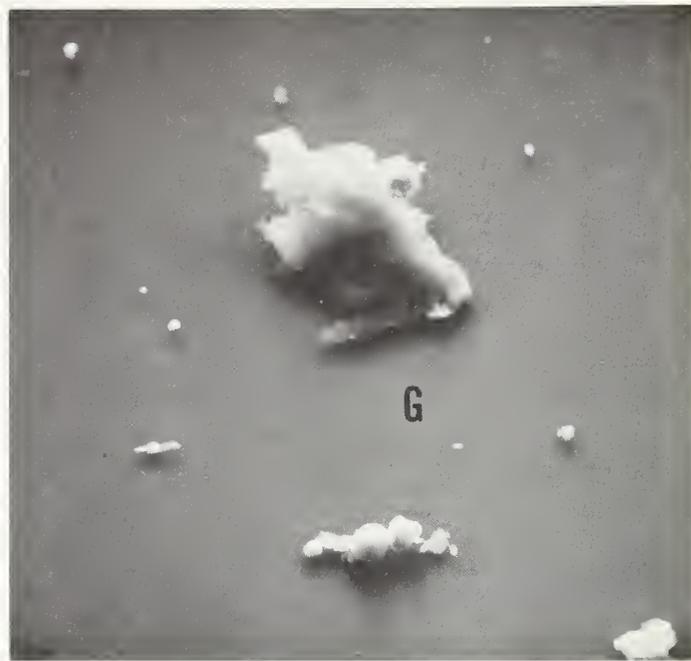
Fig. 10(a). Particle string from Region G in Fig. 5. (slightly outside area shown). Spheroidal particle diameter is  $4.5 \mu\text{m}$ . Large blob gives typical background X-ray spectrum.  $M = 1,000X$ .

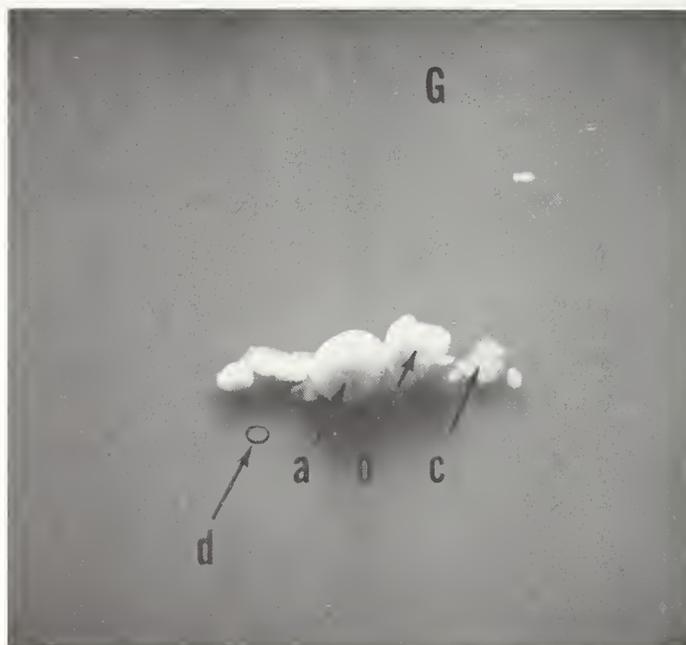
(b). Details of above string. Note contrast differences between particles. X-ray emission spectra were obtained from labeled particles. Spheroidal particle is iron. Particle (c) contains oil residue.  $M = 2,000X$ .

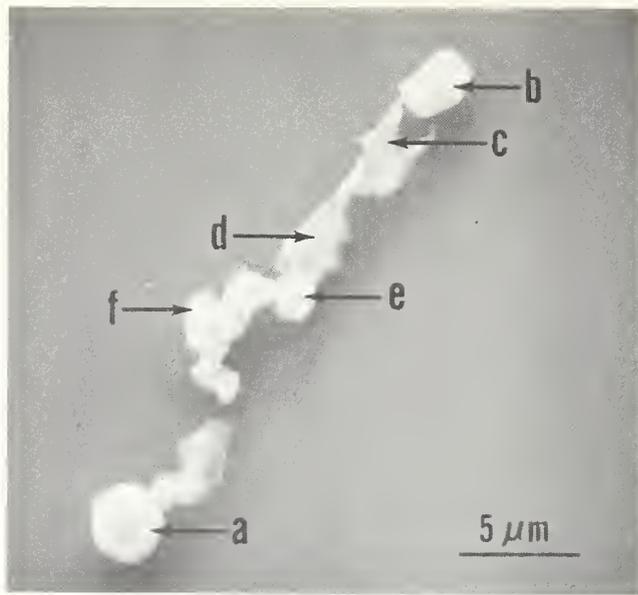
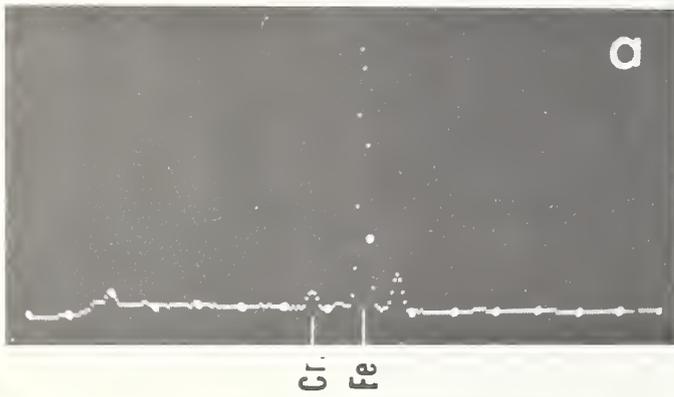
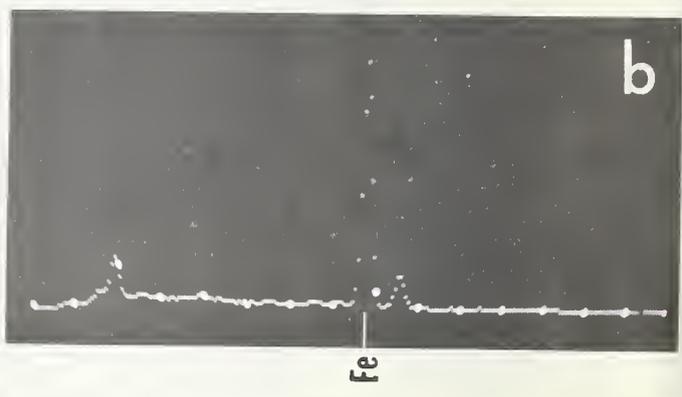
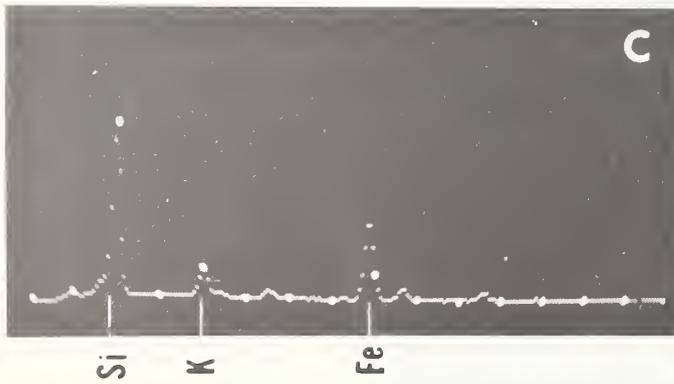
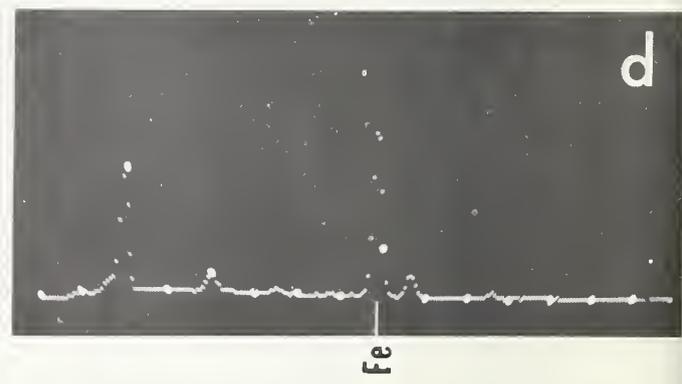
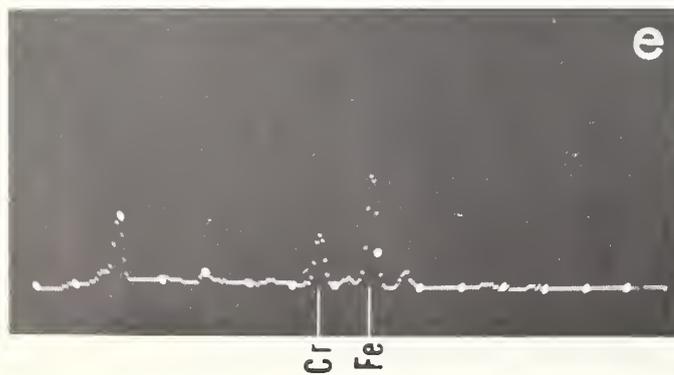
Fig. 11. Particle string from F-2117 with X-ray spectra as indicated.

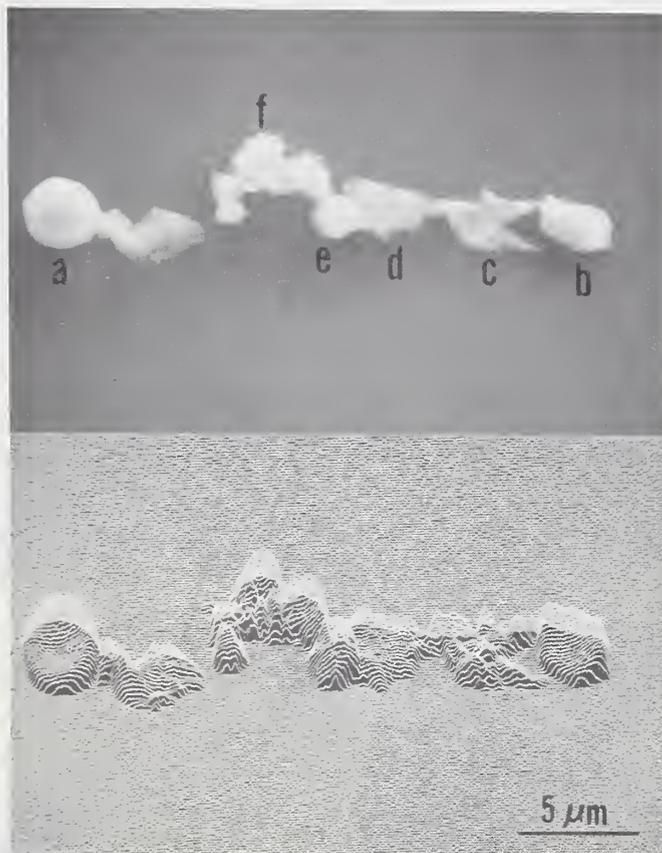
Particle			Peak Heights
Shape	Size ( $\mu\text{m}$ )	Ident.	$K_{\alpha}$ - 1,000 cts Fe : Other
a - spheroid	3	alloy steel	1.1 : 0.1Cr
b - lump	3	iron	1.1
c - flake	3	iron oxide	0.3 : 0.7Si
d - lump	3	iron oxide	0.7 : 0.5Si
e - lump	2	alloy steel oxide	0.5 : 0.2Cr : 0.2Si
f - lump	1.5	iron	0.8

Fig. 12. Particle string above showing intensity variations in Y-modulation. Analysis results are shown.

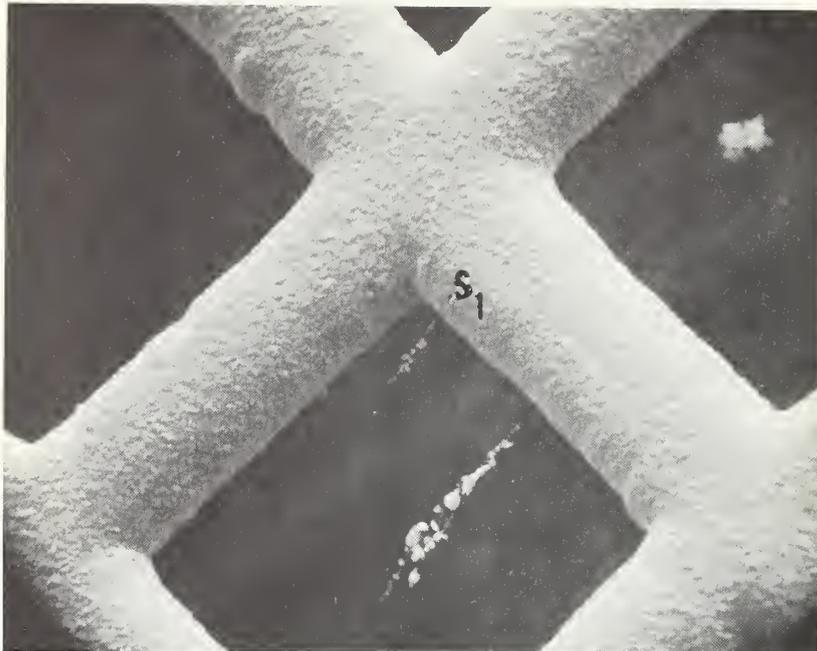
Fig. 13(a).  
F-1851. One support grid opening containing two particle strings on carbon film in SEM.  $M = 600x$ .

A second study was conducted on wear particles from the SKF test of 52100 steel ball bearings. Rather than carbon-coat the Ferrogram-1851, we removed the particle strings from the glass substrate by extraction replica techniques. This would permit high resolution imaging in a transmission electron microscope (TEM) and transmission electron diffraction (TED) examination, particularly of the smaller particles. A softened polymer film was pressed onto the Ferrogram, allowed to harden, stripped off, and overcoated with carbon, and then the polymer film was dissolved in solvent. The resulting carbon film contained the partially embedded particle strings and was supported on a conventional copper grid that could be loaded directly into the TEM specimen holder. Figure 13a shows two strings located in one grid opening. This same area is shown in the optical microscope photograph in Fig. 13b, indicating the versatility in this preparation and mounting technique.

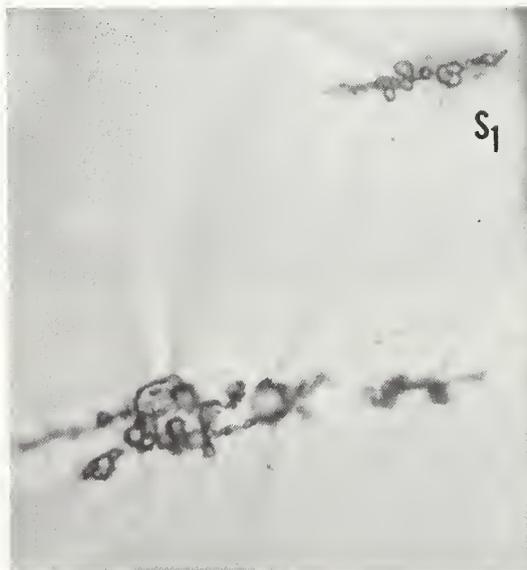
(b). String  $S_1$  on carbon replica in the optical microscope.  $M = 1,000x$ .

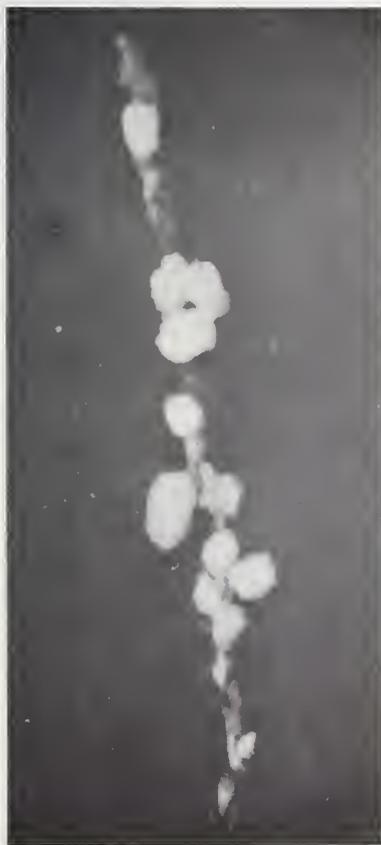
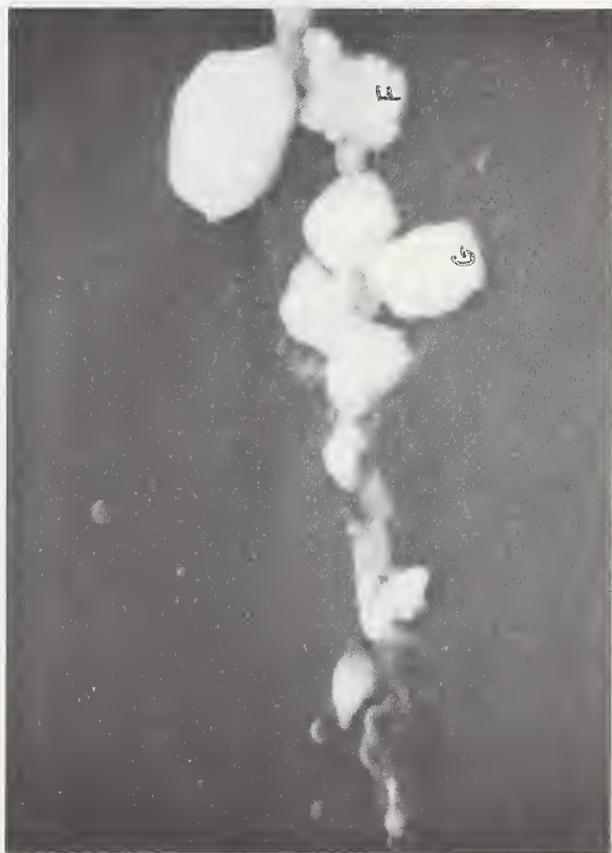
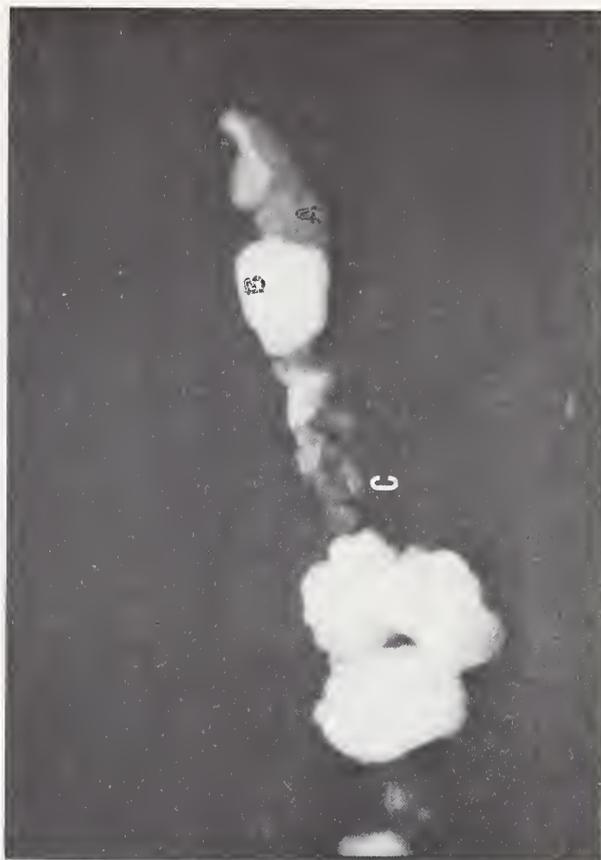
Fig. 14. String S<sub>1</sub> in SEM. Note contrast differences among particles. M = 5,500x. Details below at M = 11,000x.

In summary, the string  $S_1$  contains a number of different particle types. Thinner particles may be solid iron, composed of many crystallites (A), they may be a loose collection of much smaller iron oxide particles (C), or they may be relatively thick iron particles with an oxide coating (B). No carbide particles were found in this string. A more detailed electron diffraction pattern is shown in Fig. 17 with the principal lines for  $\alpha$ -Fe and  $Fe_3O_4$  identified. The  $Fe_2O_3$  pattern contains two additional lines that serve to distinguish it. As long as sufficient diffraction intensity is obtained, solutions of patterns from particles are straightforward.

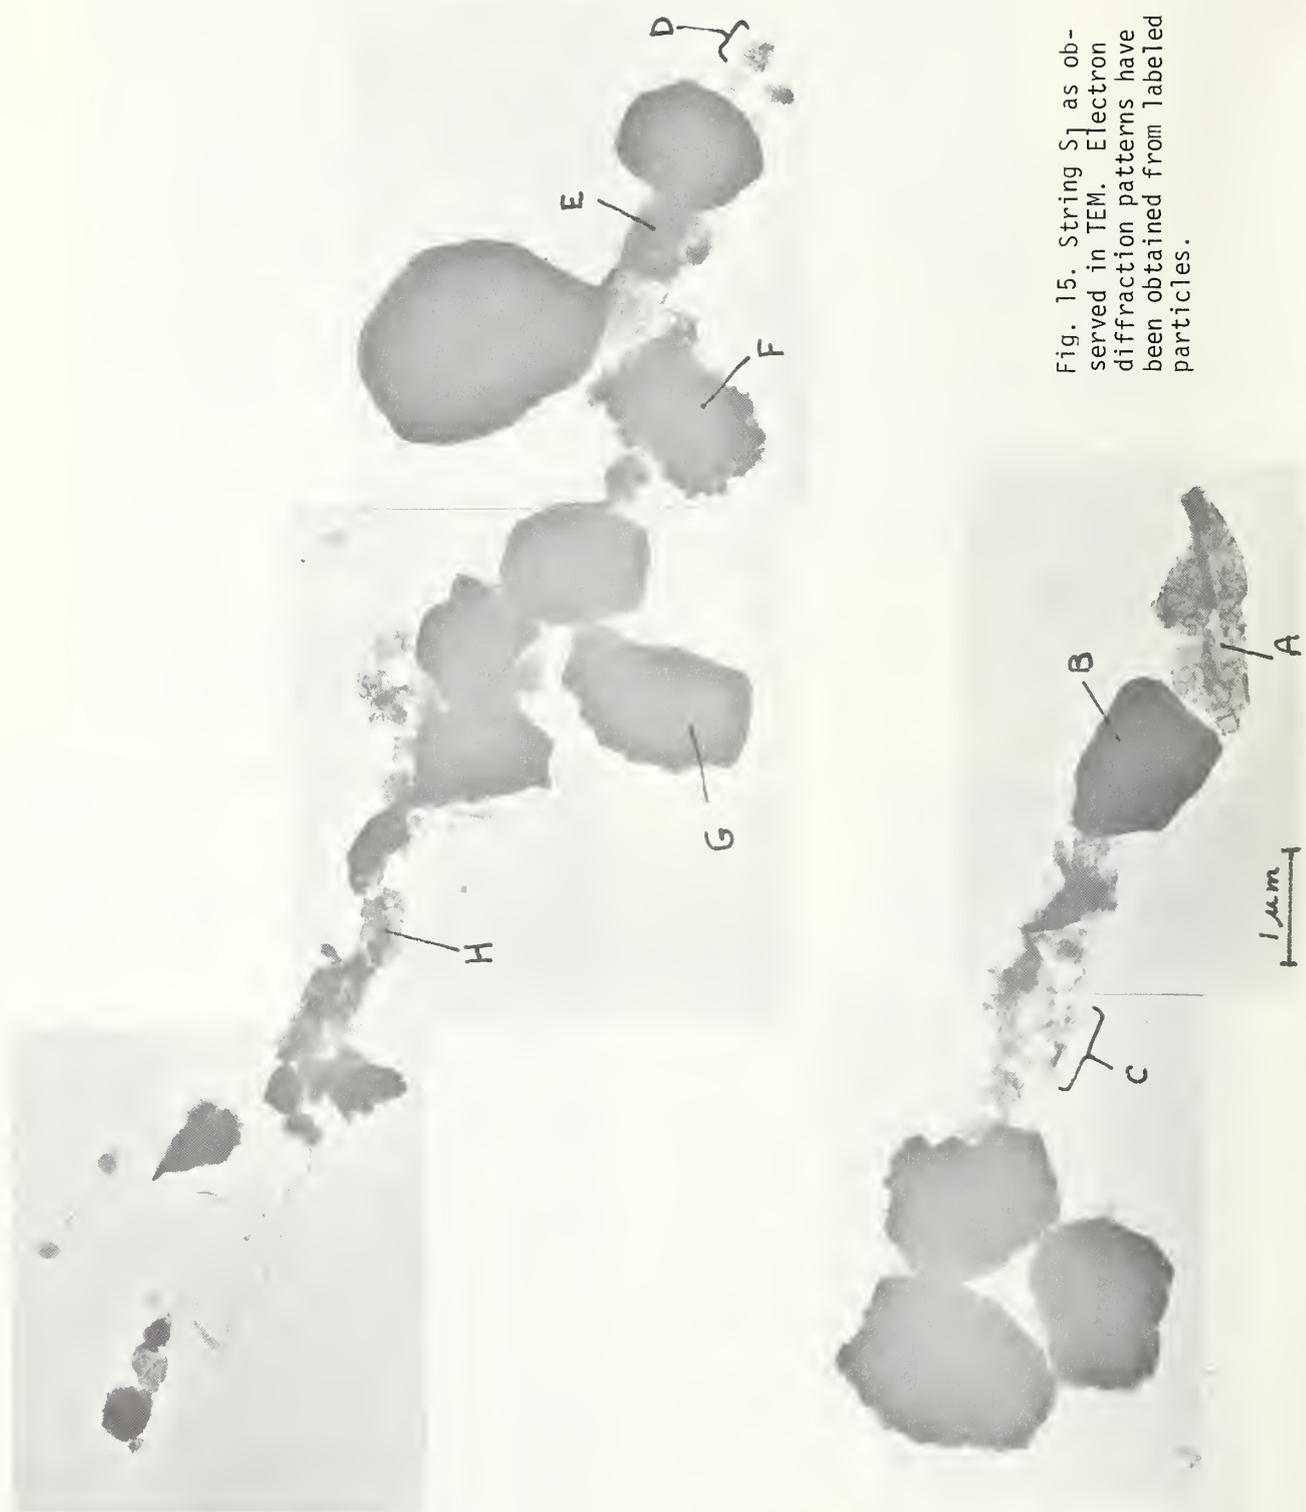
Fig. 15. String S] as observed in TEM. Electron diffraction patterns have been obtained from labeled particles.

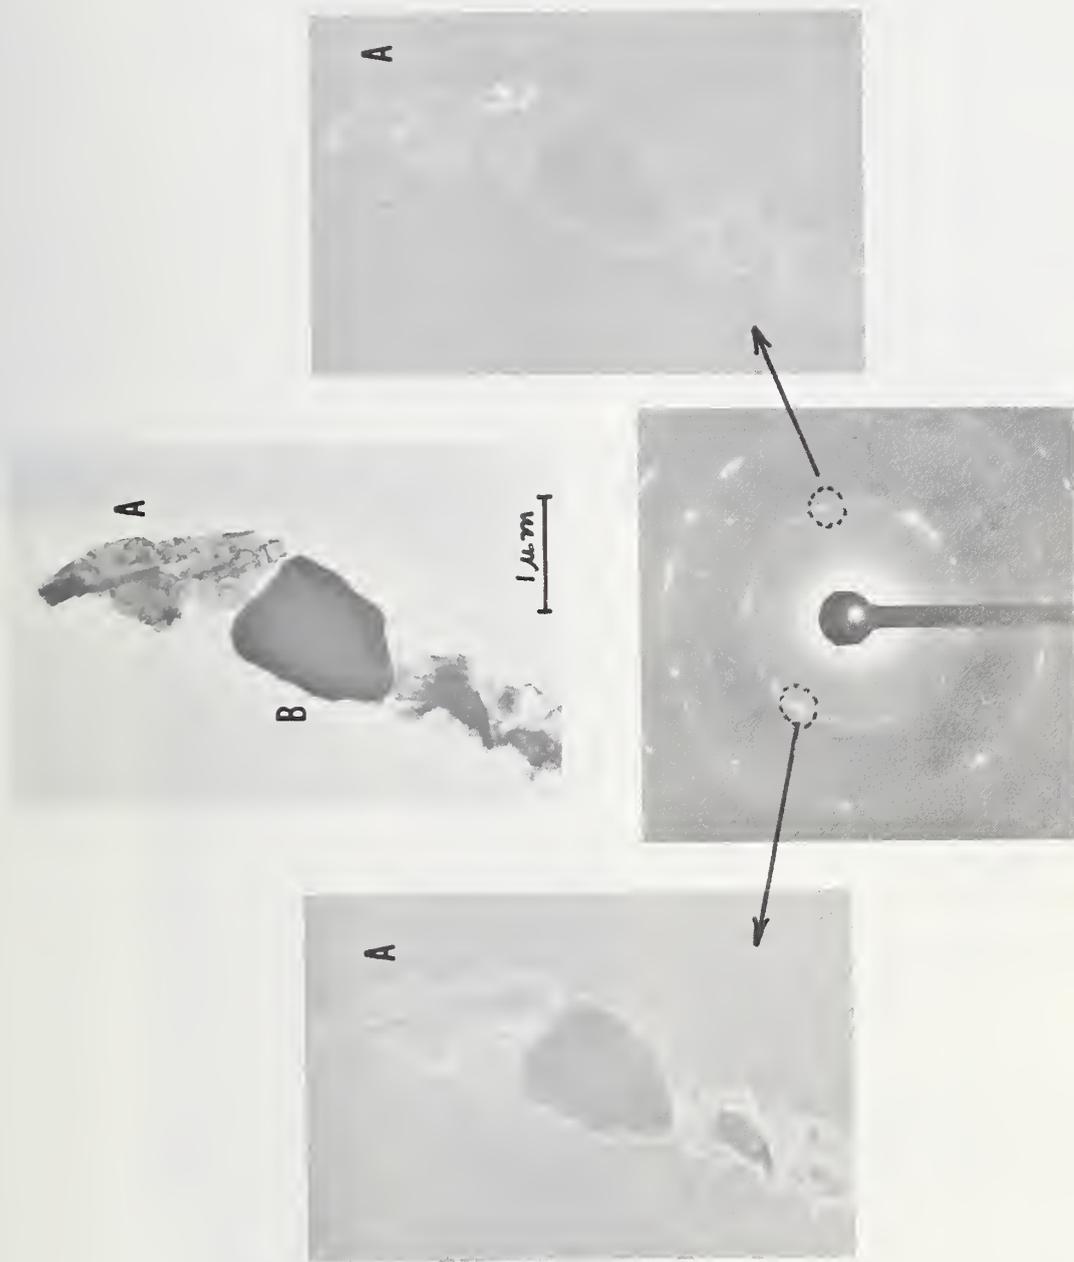
Fig. 16. Particles in string S<sub>1</sub> imaged in TEM bright field and two dark field reflections (iron and iron oxide). Note oxide covering at edge of opaque iron particle.

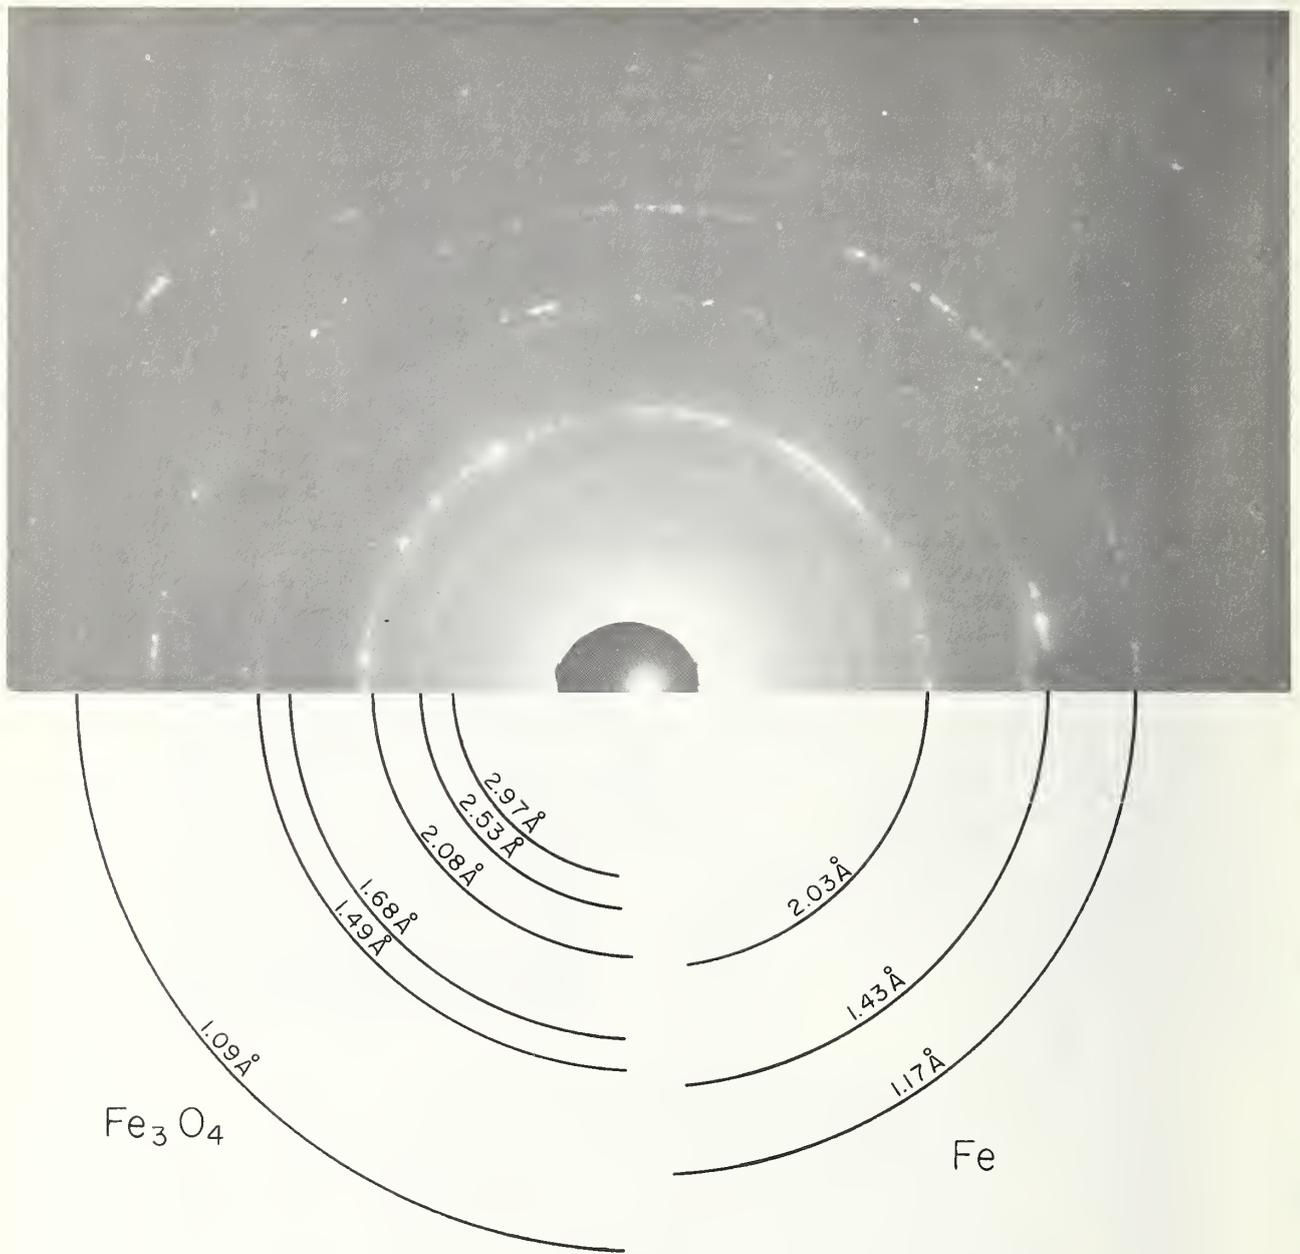
Fig. 17. Electron diffraction pattern from an area of partially oxidized iron particles in one string. F-1851.

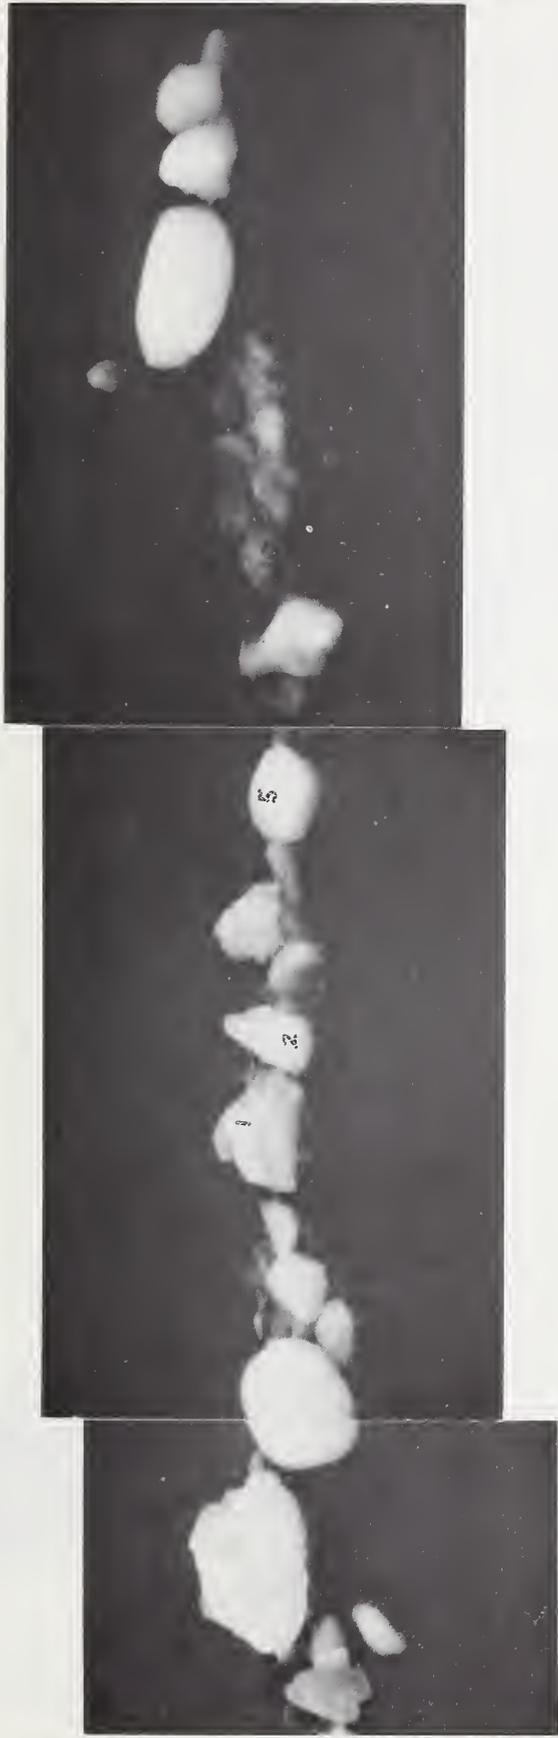
Fig. 18. String S<sub>2</sub> in SEM. Note contrast difference among particles. M = 11,000x.

Another string ( $S_2$ ) is shown in Fig. 18. Again considerable size and shape variation among the particles is seen. Fine structural details can be observed here in emissive mode imaging. The brightness differences between particles are seen again in this string. A portion of this string is shown in the TEM micrograph composite of Fig. 19. The labeled particles have been studied in diffraction. Particles 1, 3a, 3b, 9b, and 12 give principally iron oxide patterns. Particles 2, 4, 5, 7, 10, 13, 14, and 15 give strong  $\alpha$ -Fe patterns. The remaining particles studied showed both iron and iron oxide content to a substantial amount. Some of the thinner particles (10, 13, 14, 15) appear to be solid, partially-oxidized iron fragments. Other particles (3a, 9a) appear to be more a collection of small fragments, principally iron oxide.

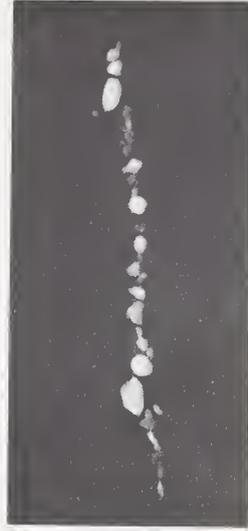
F-1851. String S<sub>2</sub> observed in SEM. M = 2,200x.
